Manhole Inspection Summary

Manhole # S39A2_024MH

Insp Date: **4/24/08 9:52 AM**

Location Address: **601 Washburn Ave.**

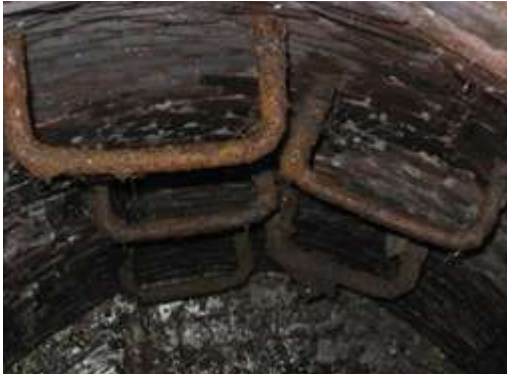
Count: **4** Missing: **0** ☒ **Corroded**

steps

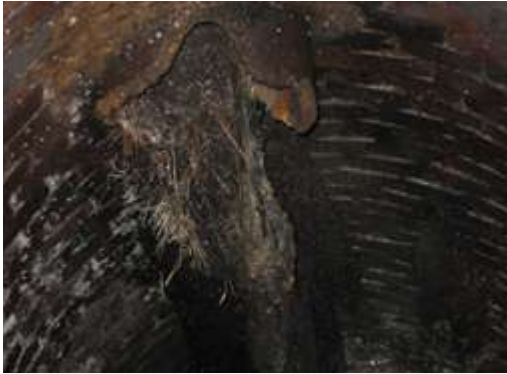
Defect 1

Condition: ☐ Sound ☐ Cracked ☒ **Root Intrusion** ☐ Loose Brick ☐ Deteriorated

Infiltration: ☐ None ☐ Joint ☐ Cracks ☐ Mortar ☒ **Roots** ☒ **Wall**

tree root growing through pipe and drop extension

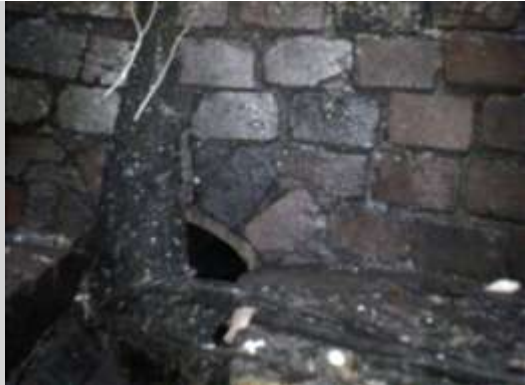
12 O'Clock Outflow

Pipe Height: **8.4** (in.) Rod and Bar (Angled)
Pipe Material: **Clay** ☐ Pipe Lined
Invert Depth: **10.28** (ft.) Flow Characteristics: **Slow**
Deposits: ☒ None ☐ Mud ☐ Sludge ☐ Debris ☐ Grease
Silt Depth: (in.) Deposits Extent:
Infiltration: **None** Pipe Seal Cond: **Sound**

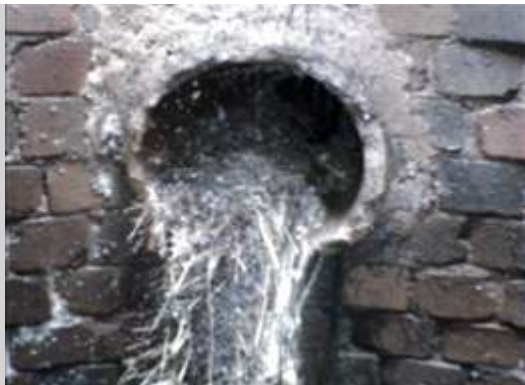
6 O'Clock Inflow

Pipe Height: **7.2** (in.) Rod and Bar (Angled)
Pipe Material: **Clay** ☐ Pipe Lined
Invert Depth: **4.01** (ft.) Flow Characteristics: **Slow**
Deposits: ☒ None ☐ Mud ☐ Sludge ☐ Debris ☐ Grease
Silt Depth: (in.) Deposits Extent:
Infiltration: **None** Pipe Seal Cond: **Sound**

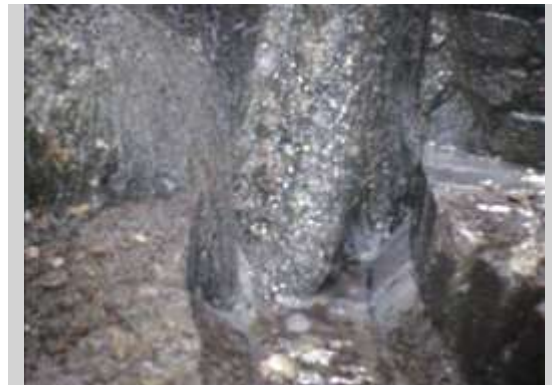
Drop In @ 6 O'Clock

Drop: **Inside** Rod and Bar
Angled: **Yes** Reading: **8.92** (ft.)
Inv Depth: **9.92** (ft.)
Drop Condition: **Open**
